CIVIL AERONAUTICS BOARD

ACCIDENT INVESTIGATION REPORT

EASTERN AIR LINES—NEAR BAINBRIDGE, MD., MAY 30, 1947**The Accident**

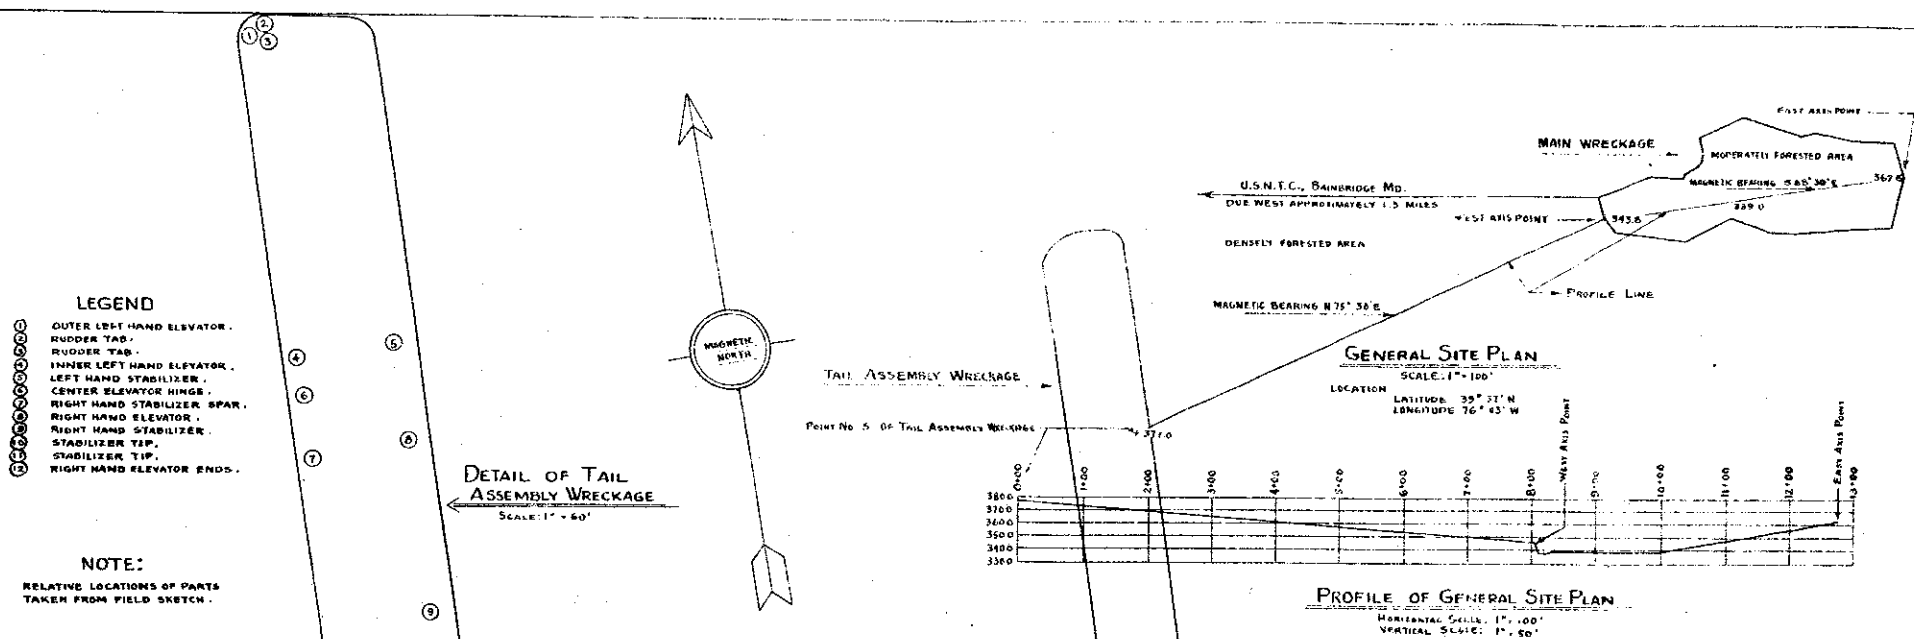
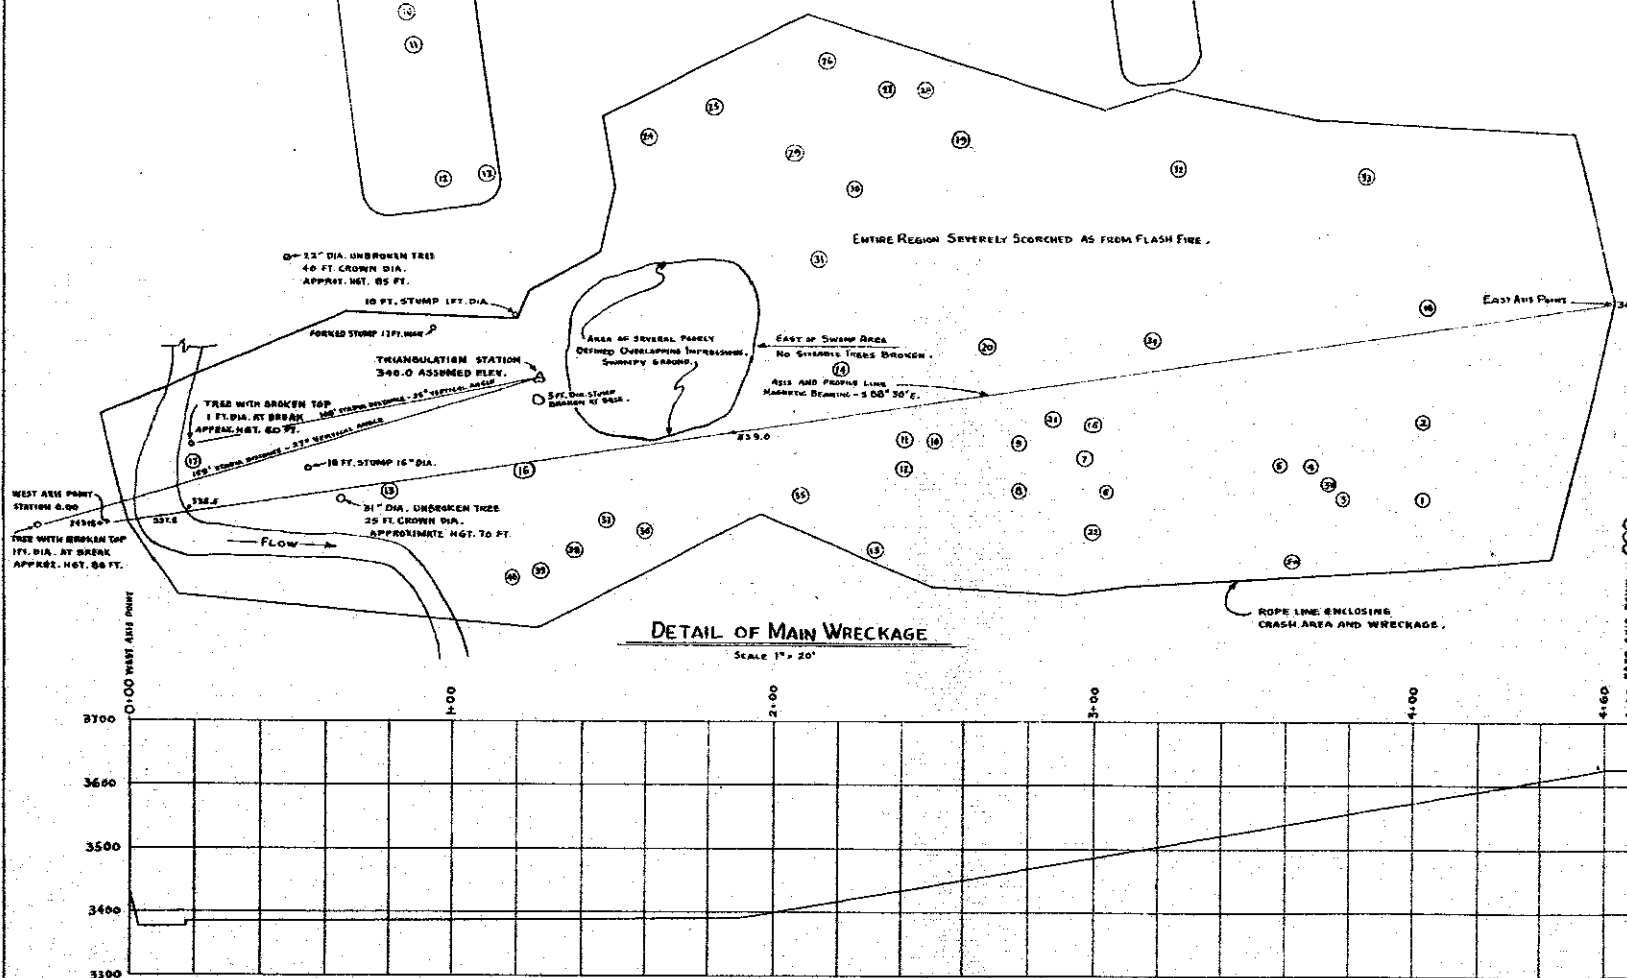
NAVAL TRAINING CENTER, BAINBRIDGE, MD.
WRECKAGE DISTRIBUTION
of
CRASH OF EAL-C54B-DC-NC88014
NEAR BAINBRIDGE, MD. ON MAY 30, 1947

Impact with the ground was about 2 miles east of Bainbridge, on Amber 7 Airway, in a moderately to densely wooded area with trees 60-70 feet high. The aircraft broke up into a large number of pieces which were strewn irregularly over an area roughly 500 feet long and 150 feet wide with the explosive-like violence common to high-speed crashes. The direction of the long axis of this area, from the initial impact end, was about 90° or nearly east, and opposite to the flight's original westerly course. A quite clear-cut path of trees, broken at decreasing heights, indicated that the plane came through them at an angle of 28°-30° below the horizontal. Near both sides of this line of broken trees were closely-spaced unbroken trees. Examination of the wreckage indicated that the plane was inverted at impact with its left wing low. A flash fire which followed burned leaves and foliage and scorched tree trunks throughout the wreckage-strewn area, there was no sustained or concentrated fire. (A detailed sketch of the crash site is attached.)

A study of the distribution of the wreckage indicates that parts of the empennage left the aircraft at about the same time, and at low altitude, otherwise their resting places would have been far more scattered. No part of the aircraft was found anywhere except in the areas of the main wreckage or of the tail wreckage.
